VIRUSCAST 3 – Third issue

Being the Northumbria Nortons Bananavirus Newsletter,

Mk3 Commando Electric start - - - - - ?

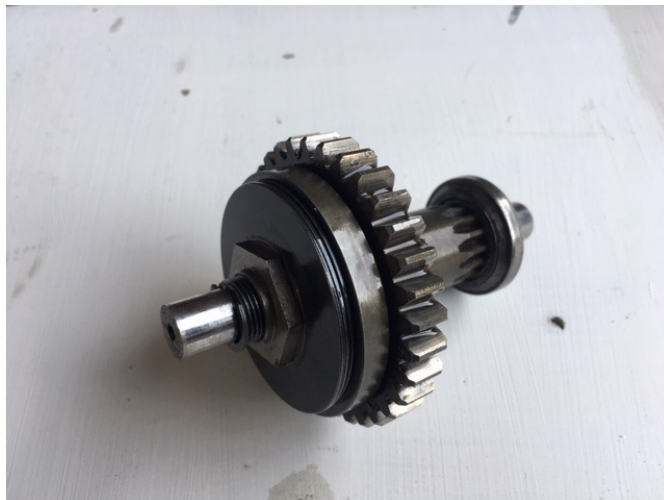
Well, Recognise this?

My guess is that not

many of you will. It's

the anti-backfire device from a Mk3 Commando. Here's a photo of it in context.

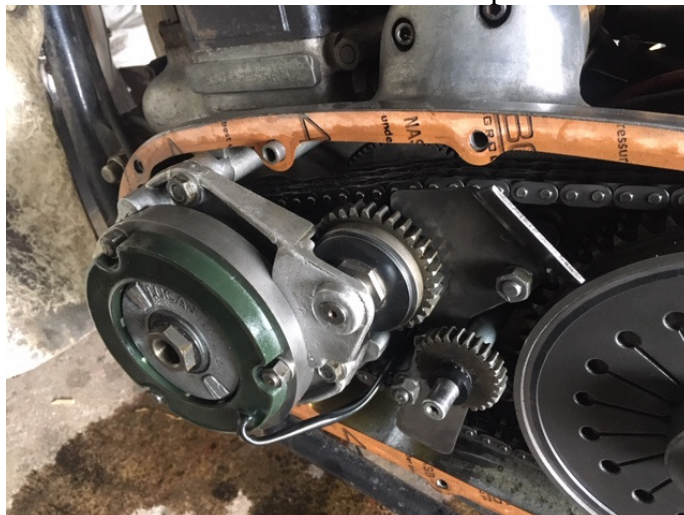
I was unable to investigate at the time due to the rally and didn't get around to checking until January this year. I had assumed that the sprag clutch had failed. Instead found that the nut on the end of the backfire device had shattered, the 6 ball bearings were at the bottom of the primary chaincase along with the fragments of the nut. It's not clear why the nut had shattered. Richard thought it was over hardened, but it was also over 40 years old. Ashley at Andover Norton (who is their electric start guru) reckoned he'd never heard of this nut failing, whilst sprag clutch failings are well known.

Finally to protect against the consequences of backfires, I dismantled and carefully reassembled the anti backfire device. I'm not going to explain in detail how this was done. It's hardly described in the official workshop manual (or the Haynes one) but I used the really useful information at http://www.oldbritts.com/e_start_backfire.html

After I set up the slip torque at 50 ft lbs, The whole electric start system worked from about 8 years until last year, just before the Morpeth rally, I found the starter motor spinning but nothing happening to the engine!

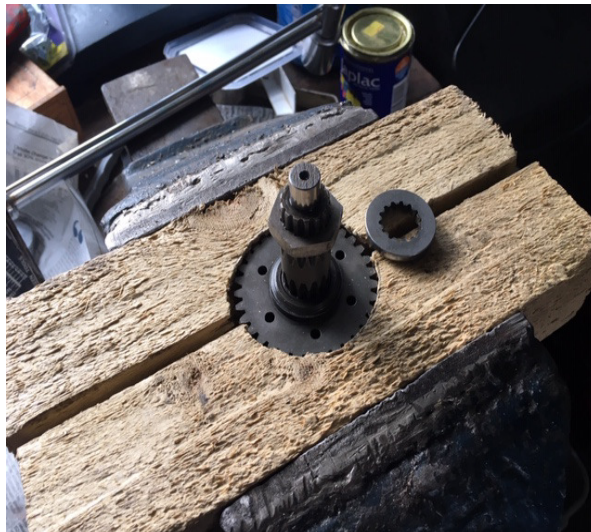
However when held properly I found the device slipping at an indicated 45 ft lbs using my bendy bar type torque wrench but if I tightened the adjusting nut by say 15 degrees, the whole device locked up and wouldn't slip at any torque I could manage. In the end I concluded that the Belleville washers (which are a kind of spring) had become tired. I invested in 3 new Belleville washers (06-4740) at £1.45 plus vat each from Andover Norton.

The only place I could hang this on the torque wrench was next to the handle 13.75" from the fulcrum. This gave a reading of 56 ft lbs but should have read 67.7 ft lbs. The reading was 11.7 ft lbs too low (an error of 20%). With the new Belleville washers I adjusted the load on the Belleville washers to get a slip at an indicated 61 ft lbs. Since the adjusting nut slips every time you test the slip torque you need to mark it some way, but once I was certain of the correct position I applied Loctite to the nut the nut and left it for a couple of days then tested it a few times before assembling the bike.
